REPORT 14318 ADDENDUM

Re-Inspection of Subject Property

**34 Timberline Road
Wynrow, Your State/Province
80204**

Original Inspection Date **Saturday, December 11, 2010**
Return Visit [Re- Inspection] Date **Friday, January 7, 2011**

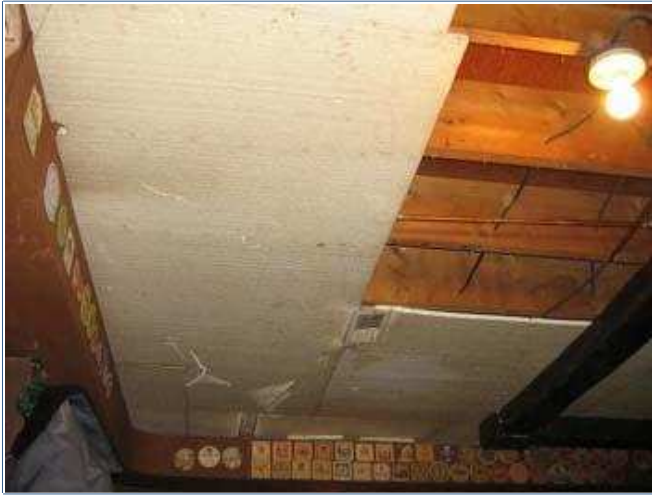
Styrofoam used as ceiling finish material

18	Rigid foam insulation is installed in an exposed location	<input checked="" type="checkbox"/>	<input type="checkbox"/>	<input type="checkbox"/>	Insulation material removed from premises
19	Improper slope of drain pipe	<input checked="" type="checkbox"/>	<input type="checkbox"/>	<input type="checkbox"/>	Plumber has reviewed and corrected all deficient plumbing fixtures and piping
20	An improper style of trap has been installed	<input checked="" type="checkbox"/>	<input type="checkbox"/>	<input type="checkbox"/>	Plumber has reviewed and corrected all deficient plumbing fixtures and piping
21	Electrical wiring has burn marks and/or indication of overheating	<input checked="" type="checkbox"/>	<input type="checkbox"/>	<input type="checkbox"/>	Electrician has reviewed and corrected affected wiring. ESA approval obtained.
22	Missing protection of wires at boxes or panels	<input checked="" type="checkbox"/>	<input type="checkbox"/>	<input type="checkbox"/>	Electrician has reviewed and corrected affected wiring. ESA approval obtained.

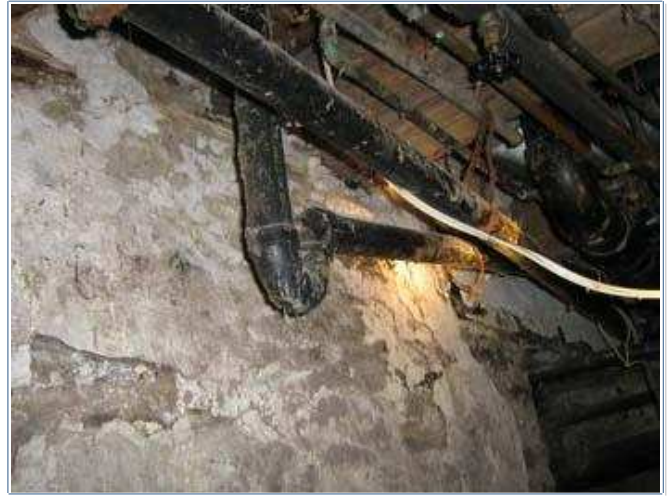
Improper slope, drainage pipe

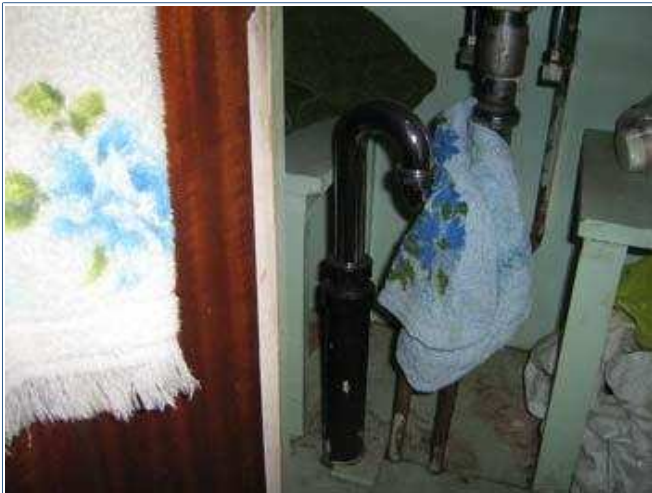
S-trap below sink

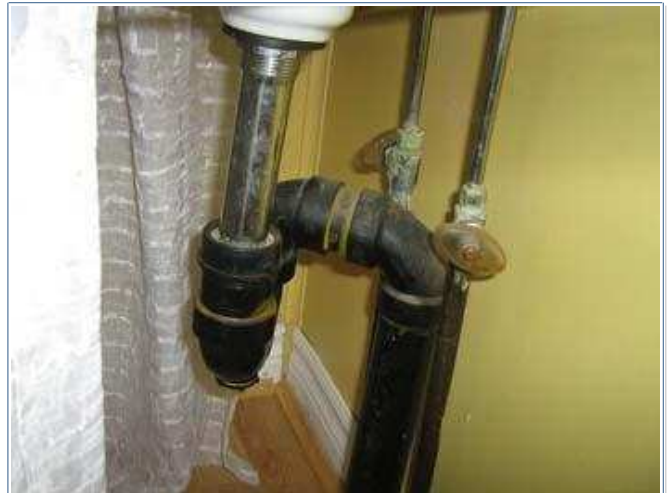
S-trap below sink

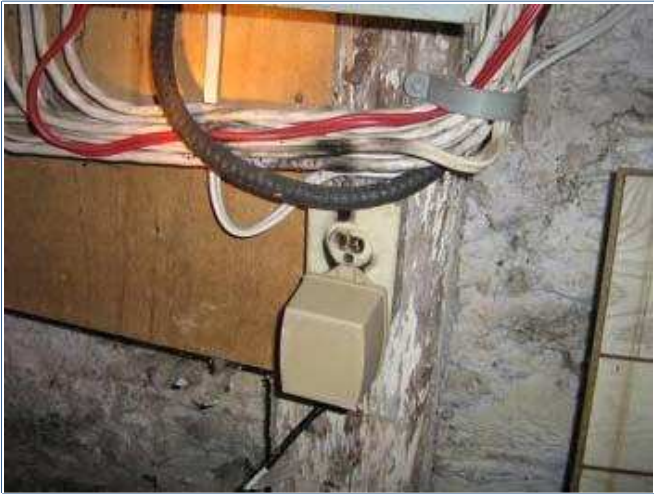
Charred electrical wiring

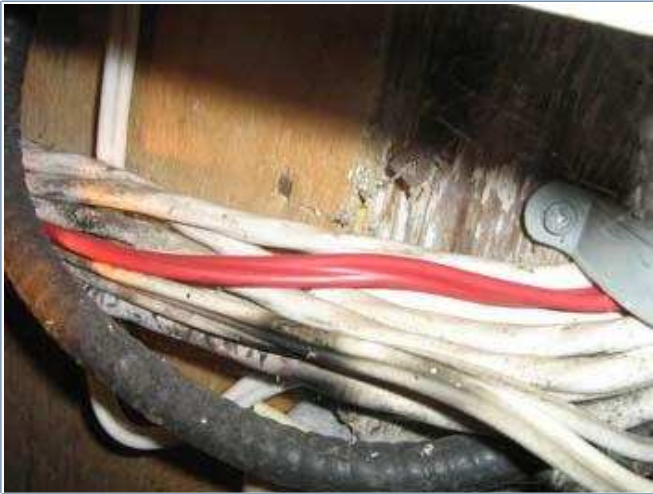
Charred electrical wiring near main electrical panel

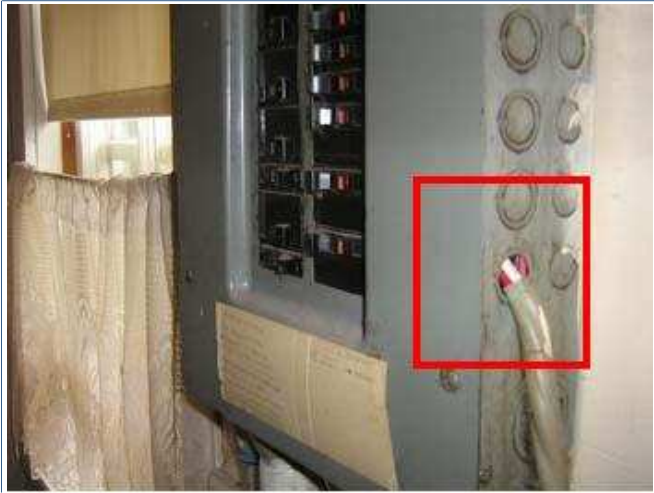
Missing wire protection at main electrical panel

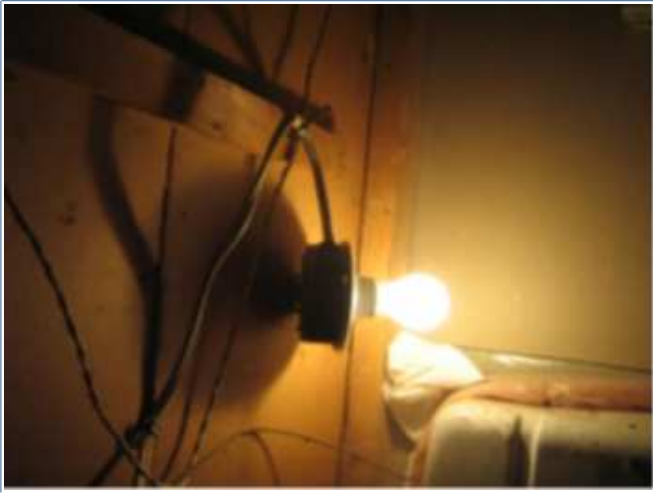
Light fixture improperly secured; near combustibles

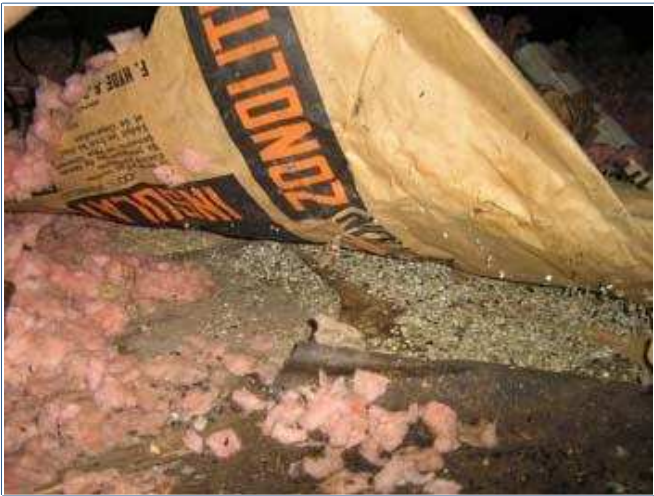
Insulation System	<input type="checkbox"/>	<input checked="" type="checkbox"/>	<input type="checkbox"/>	No action undertaken and no commitment expressed to test attic insulation [vermiculite] and to remove if confirmed to contain asbestos.
Plumbing System	<input checked="" type="checkbox"/>	<input type="checkbox"/>	<input type="checkbox"/>	Plumbing repairs completed. However, plumber wants to perform additional checks and examinations on the plumbing system to identify any other deficiencies.
Electrical System	<input checked="" type="checkbox"/>	<input type="checkbox"/>	<input type="checkbox"/>	All electrical repairs have been completed.
	<input type="checkbox"/>	<input type="checkbox"/>	<input type="checkbox"/>	
	<input type="checkbox"/>	<input type="checkbox"/>	<input type="checkbox"/>

Suspect insulation: may contain asbestos

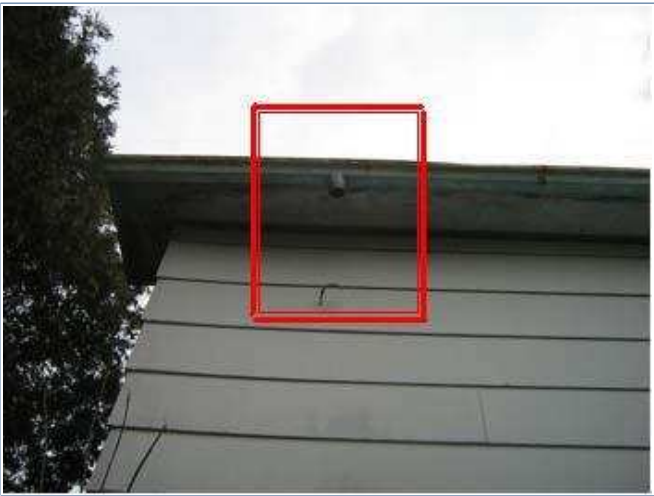
Missing downspout from gutter

REPORTED DEFICIENCY	Corrected / Acceptable	Deficient: Repairs Required	N/A	Comments
1 Downspout is missing	<input checked="" type="checkbox"/>	<input type="checkbox"/>	<input type="checkbox"/>	Repaired
2 Wood siding is rotted	<input type="checkbox"/>	<input checked="" type="checkbox"/>	<input type="checkbox"/>	Most affected wood replaced. One section on east side requires completion.
3 Exterior window frame/sill is rotted	<input checked="" type="checkbox"/>	<input type="checkbox"/>	<input type="checkbox"/>	Affected windows have been replaced with vinyl Energy Star rated window units
4 Window units are deteriorated. Observed conditions include broken/missing glass, rotted sills and sashes,	<input checked="" type="checkbox"/>	<input type="checkbox"/>	<input type="checkbox"/>	Affected windows have been replaced with vinyl Energy Star rated window units
5 Window caulking is deteriorated; general condition.	<input checked="" type="checkbox"/>	<input type="checkbox"/>	<input type="checkbox"/>	Five windows have been replaced with vinyl Energy Star rated window units. Remaining windows were re-caulked. Caulkings as applied are acceptable.

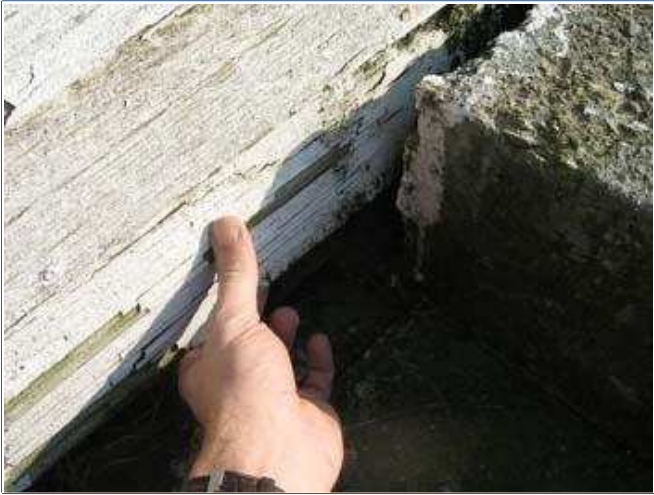
Deteriorated wood siding near grade; rot evident

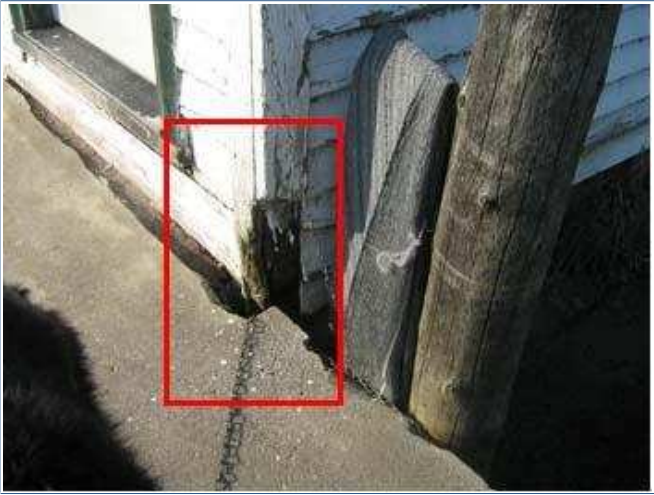
Deteriorated wood near grade level; rot evident

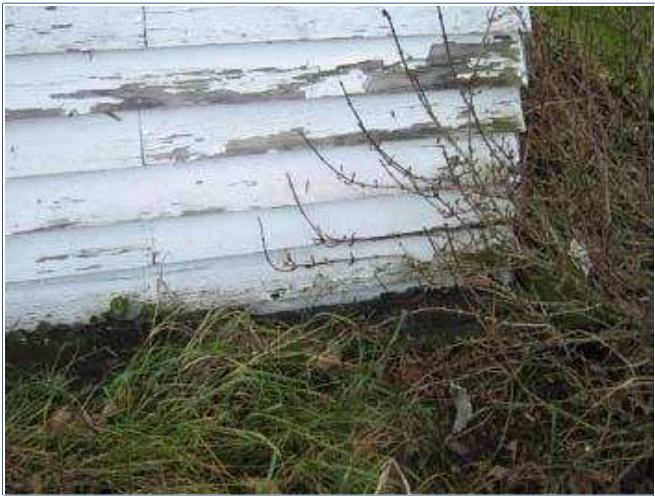
Deteriorated wood near grade level; rot evident

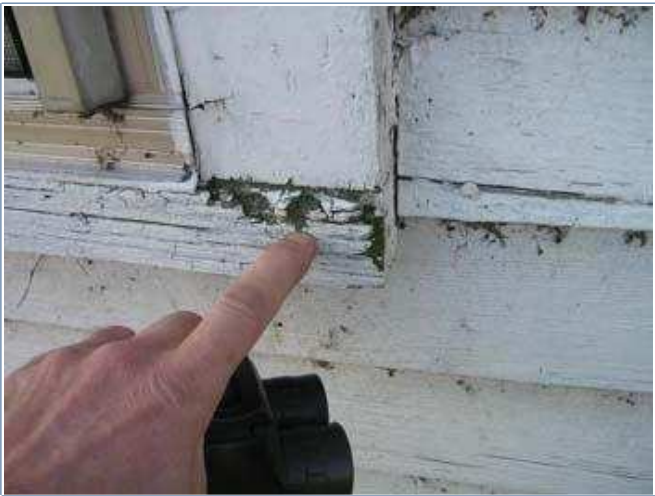
Deteriorated window frame; rot evident

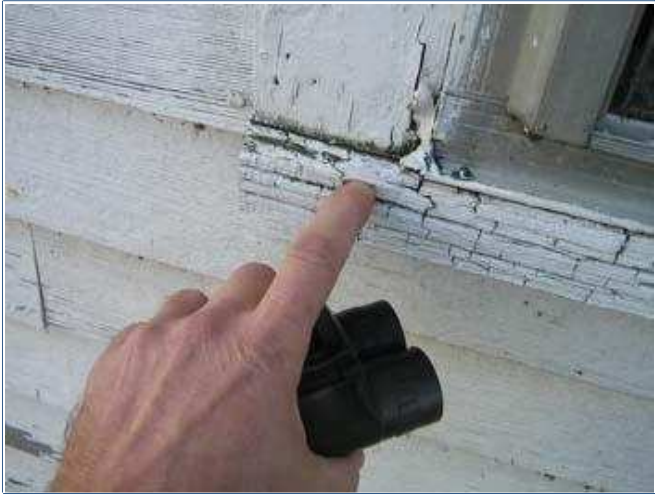
Deteriorated window frame; rot evident

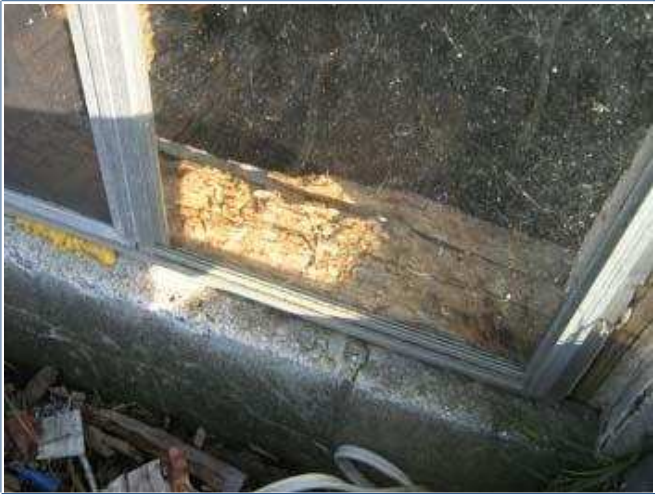
Deteriorated window frame; dry and wet rot evident

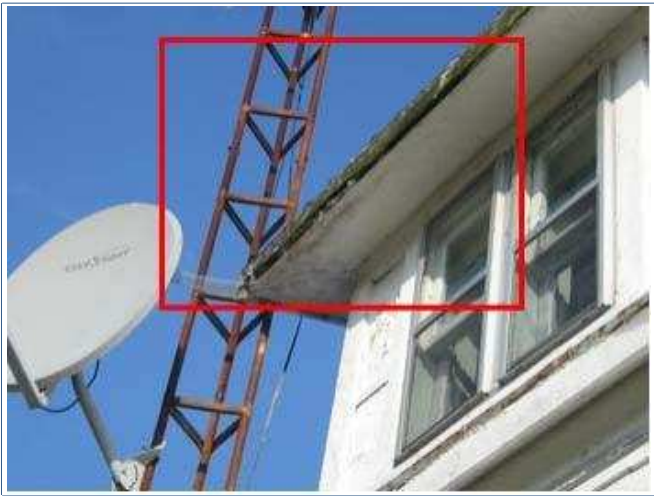
Deteriorated fascia; rot evident; leak past fascia damaging soffit.

6 Fascia is deteriorated	<input checked="" type="checkbox"/>	<input type="checkbox"/>	<input type="checkbox"/>	Fascias have been repaired or replaced. Current condition appears to be acceptable.
7 Soffit requires painting, general to all exterior roof edge areas.	<input checked="" type="checkbox"/>	<input type="checkbox"/>	<input type="checkbox"/>	Soffits have been repaired or replaced. Current condition appears to be acceptable.
8 Active leakage through roof structure is observed	<input type="checkbox"/>	<input checked="" type="checkbox"/>	<input type="checkbox"/>	Roof repairs scheduled but no other repair progress to date
9 Rot in wood beam(s)	<input checked="" type="checkbox"/>	<input type="checkbox"/>	<input type="checkbox"/>	Original beams removed and replaced. New footings and support columns installed.
10 Insufficient end support of beam(s); column not adequately secured to beam. NOTE: floor sag is noted in this floor area (kitchen).	<input checked="" type="checkbox"/>	<input type="checkbox"/>	<input type="checkbox"/>	Original beams removed and replaced. New footings and support columns installed. Some residual sag remains in floor structure in kitchen, but structural components appear to be adequate.

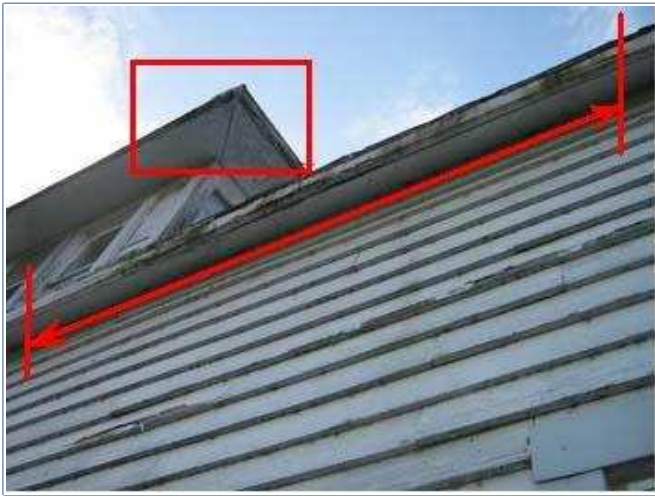
Deteriorated fascia; rot evident; secondary damage to soffits

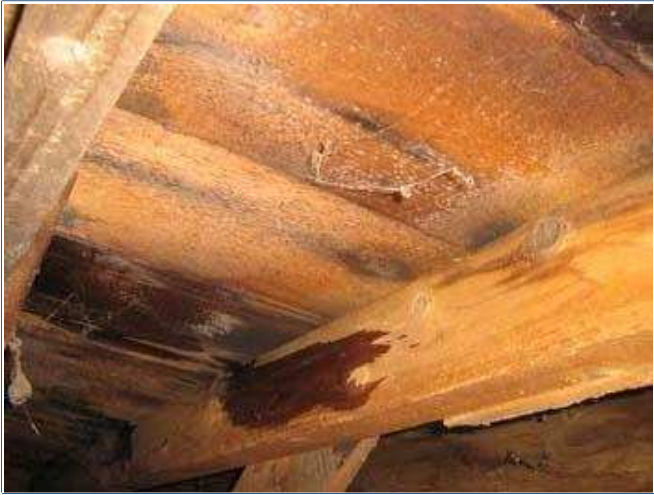
Leak past roof cover as viewed from attic

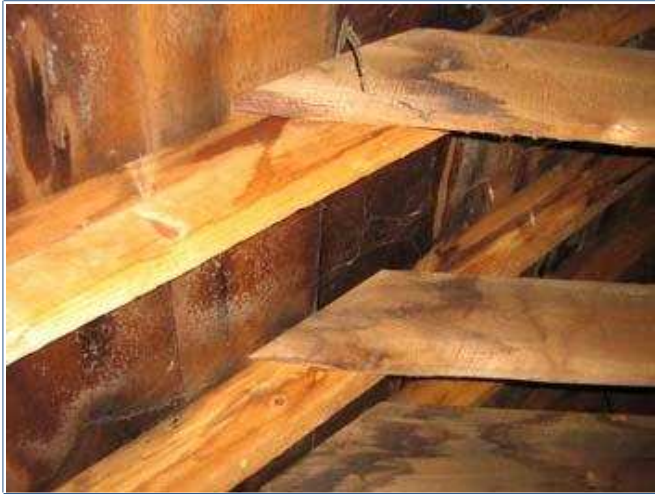
Water leak past roof cover and flashings, observed at attic

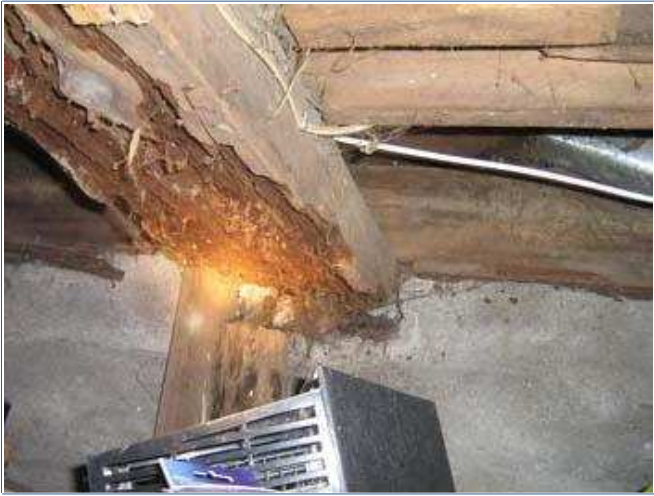
Rotted beam in basement; dry rot suspected

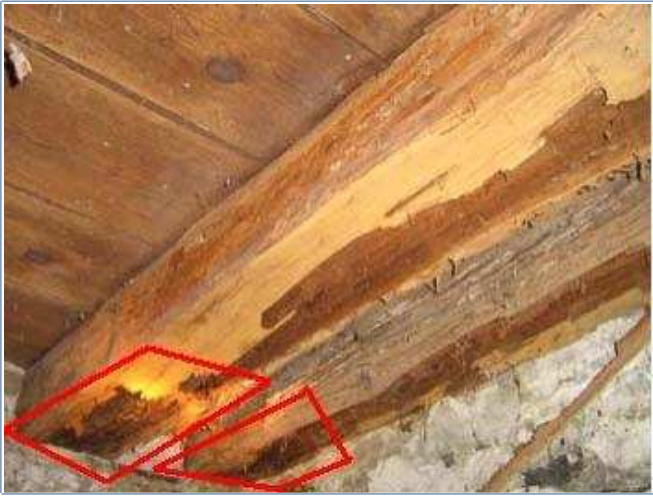
Rooted beam at pocket; dry and wet rot observed

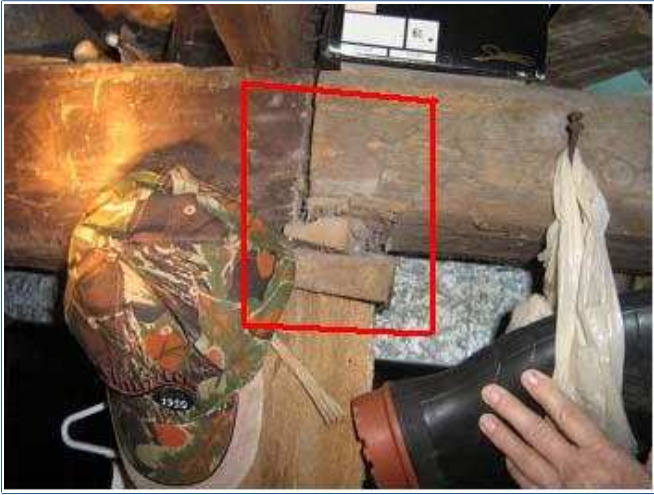
Improper beam bearing; improper column end bearing

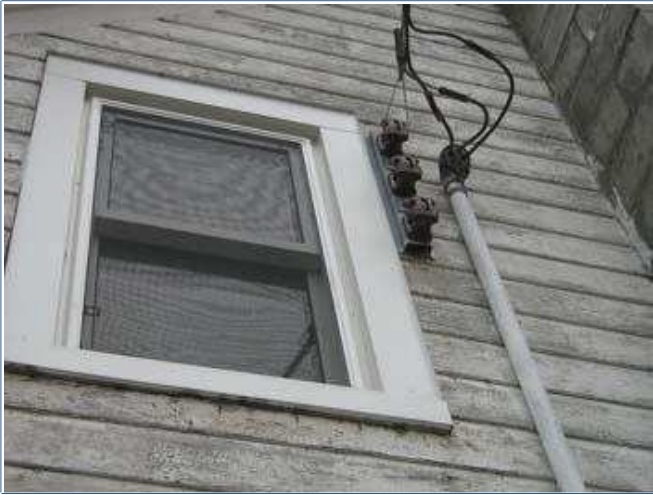
Electrical mast & weatherhead near openable window

11 Insufficient clearance of service cables at accessible locations; mast head is near an openable window.	<input checked="" type="checkbox"/>	<input type="checkbox"/>	<input type="checkbox"/>	New service mast installed with clearances per current standards.
12 Electrical outlet does not work.	<input checked="" type="checkbox"/>	<input type="checkbox"/>	<input type="checkbox"/>	Device replaced; confirmed operational. New unit is GFCI protected in weathertight enclosure.

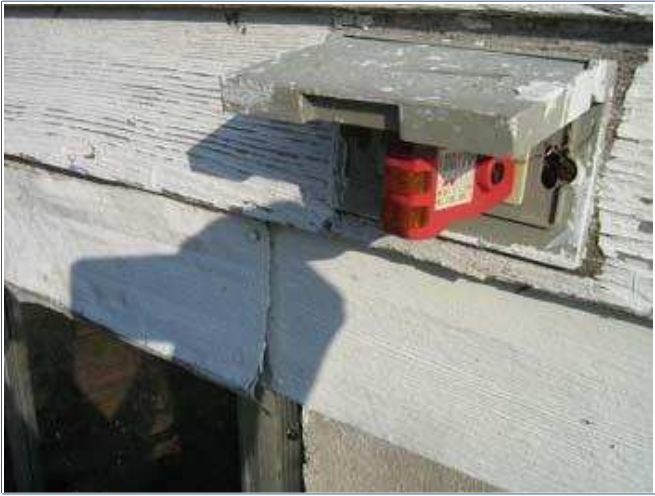
Defective outlet: fails to reset

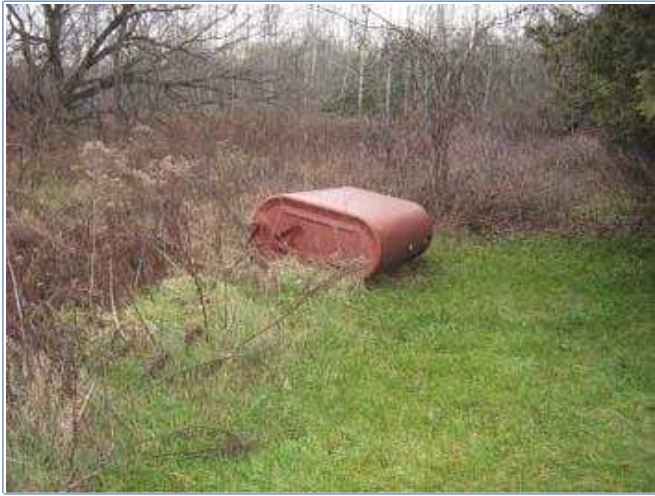
Abandoned oil tank on property

13	An abandoned oil tank is observed on the property.	<input checked="" type="checkbox"/>	<input type="checkbox"/>	<input type="checkbox"/>	Tank verified empty; removed and area certified not contaminated by contracted oil supplier.
14	Exhaust flue is corroded or rusted	<input checked="" type="checkbox"/>	<input type="checkbox"/>	<input type="checkbox"/>	Furnace replaced by high efficiency unit with exhaust direct vented to exterior
15	Stairs have damaged tread(s)	<input checked="" type="checkbox"/>	<input type="checkbox"/>	<input type="checkbox"/>	Stairs have been replaced
16	Water stains visible on interior ceiling surfaces	<input type="checkbox"/>	<input checked="" type="checkbox"/>	<input type="checkbox"/>	Repairs pending completion of roof replacement
17	Stair guard is missing at open side of stairs.	<input checked="" type="checkbox"/>	<input type="checkbox"/>	<input type="checkbox"/>	Gaurd added at stair opening edge.

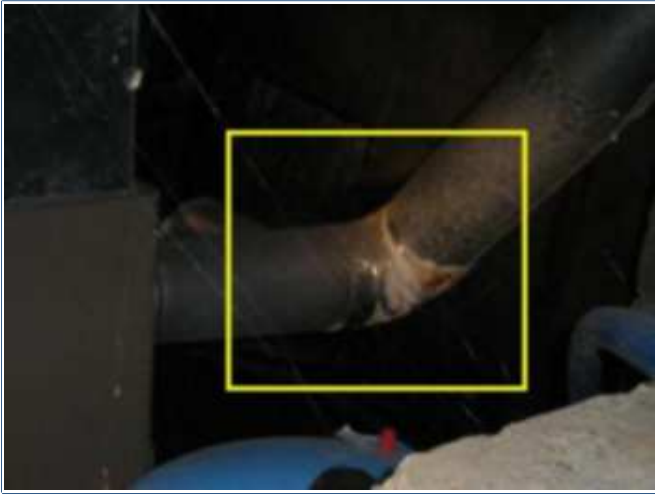
Rust/corrosion on furnace flue duct

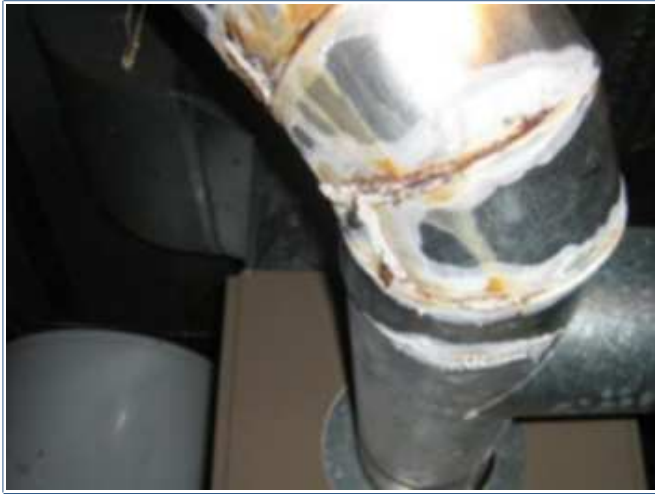
Corrosion in furnace exhaust ducting

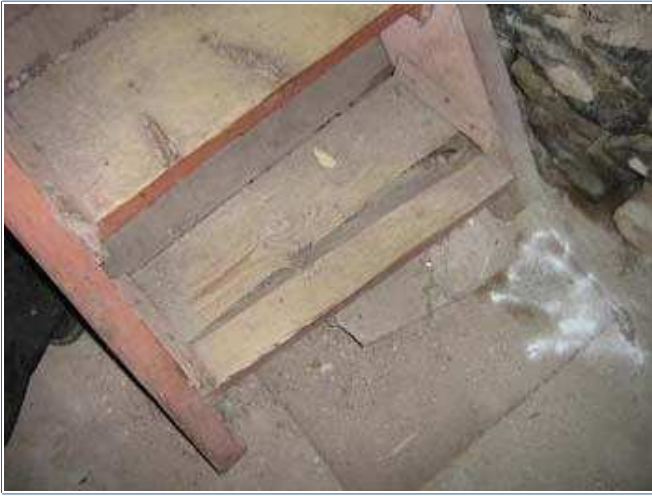
Damaged stair tread

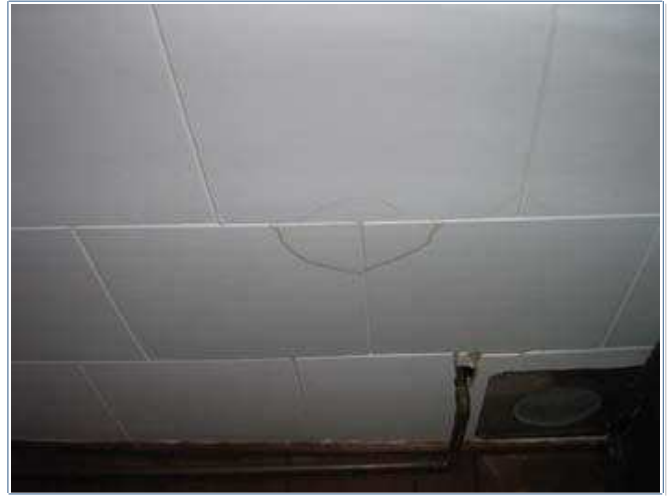
Water staining on ceiling tiles

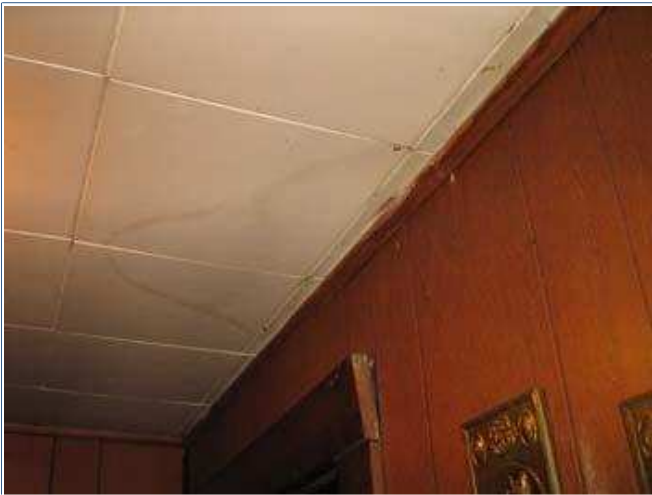
Water staining on ceiling tiles

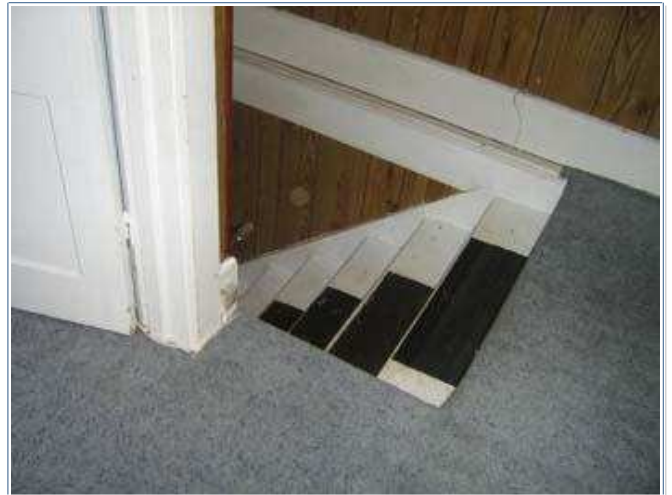
Missing opening guard and hand rail at main stairs

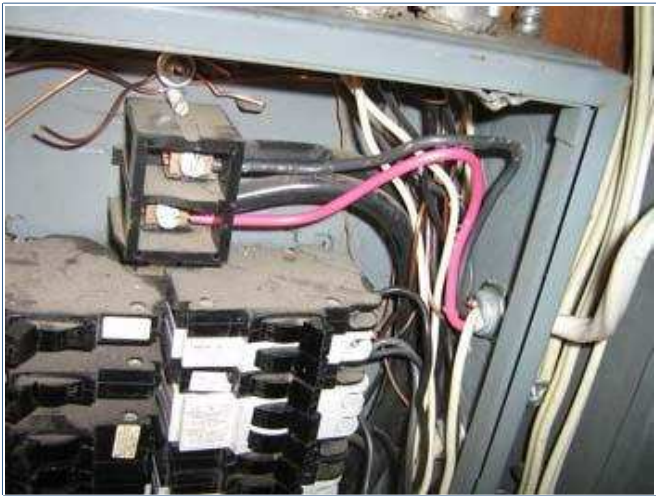
Multi-tapping at bus connectors

23	Branch circuit(s) is/are overfused. A branch circuit is directly connected to the panel bus.	<input checked="" type="checkbox"/>	<input type="checkbox"/>	<input type="checkbox"/>	Electrician has reviewed and corrected affected wiring. ESA approval obtained.
24	Unsafe installation of a junction box; a junction box is observed to not be properly secured to a framing member.	<input checked="" type="checkbox"/>	<input type="checkbox"/>	<input type="checkbox"/>	Electrician has reviewed and corrected affected fixture.
25	Insulation is of a form that may contain asbestos	<input type="checkbox"/>	<input checked="" type="checkbox"/>	<input type="checkbox"/>	No action taken to resolve this issue
26	Moisture detected at ceiling surface(s); plumbing leak suspected	<input type="checkbox"/>	<input checked="" type="checkbox"/>	<input type="checkbox"/>	Plumber identified cause and performed corrections at main bathroom toilet. Ceiling area has not been repaired.

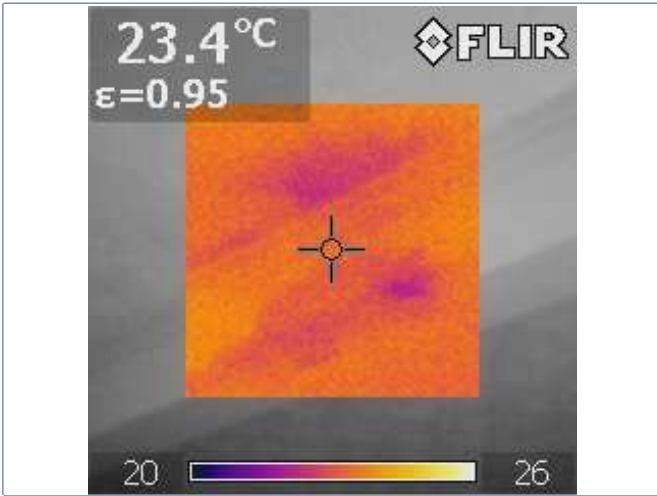
Dining Room; leak below bathroom

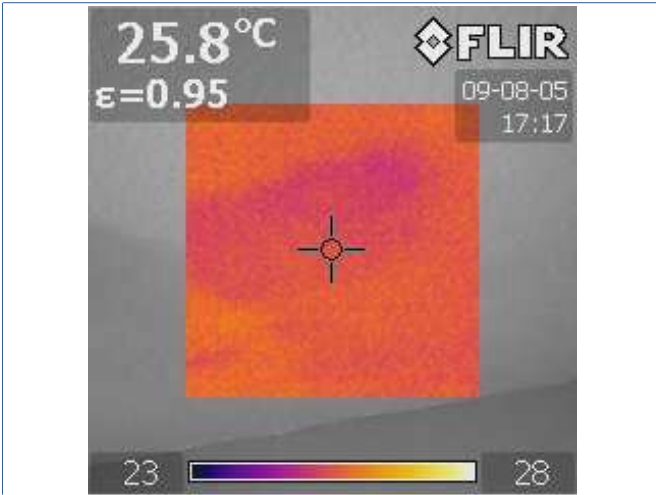
27	Moisture detected at ceiling surface(s); leak past roof cover, flashings, or penetrations is suspected	<input type="checkbox"/>	<input checked="" type="checkbox"/>	<input type="checkbox"/>	Roof cover replacement has not been completed as at time of re-inspection. Roof repairs have been scheduled.
----	--	--------------------------	-------------------------------------	--------------------------	--

Master Bedroom; leak past roof/flashings/penetrations suspected
